PROGRESS OF CONSTRUCTION WORK

Bloor Collegiate Institute Update

June 6, 2024

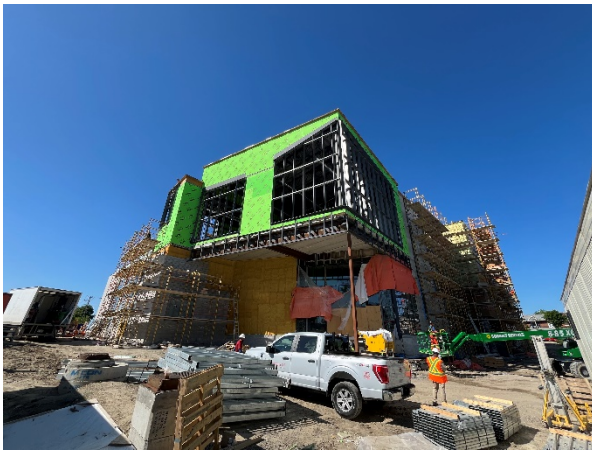
Exterior photo of the North-East corner looking at the North entrance. Third floor exterior wall has been built and mullions for glazing has been installed.

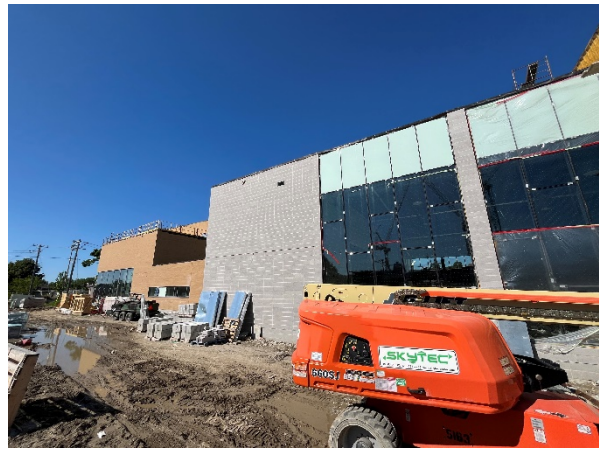
Exterior photo of the East side of the building looking towards the student commons area. Exterior block veneer and curtain wall glazing was recently completed.

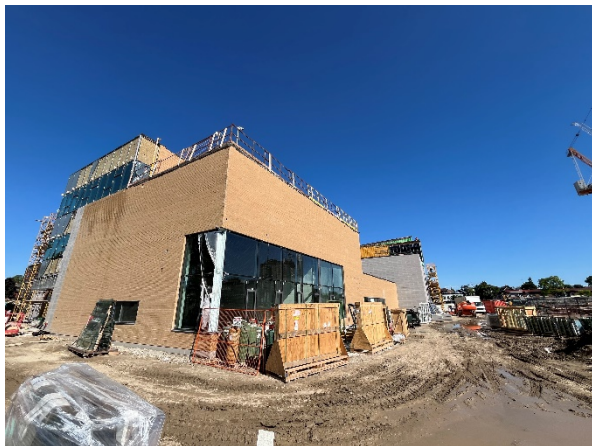
Exterior photo of the South-East corner looking at the Music Room. Parapets are built up and roof is complete.

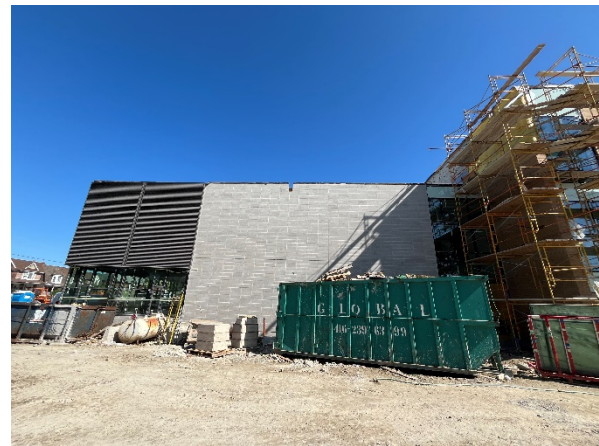
Exterior photo of the South-West corner of the building, looking at the gym. The exterior aluminum paneling was recently installed.

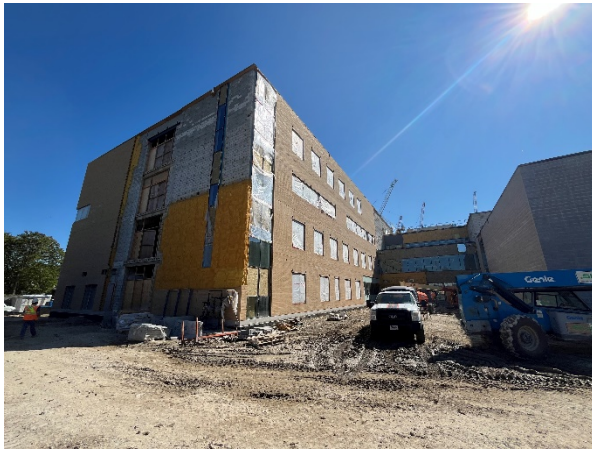
Picture taken from the West side of the building looking at the courtyard. The exterior brick veneer was recently completed in the courtyard and is ongoing on the West wall.

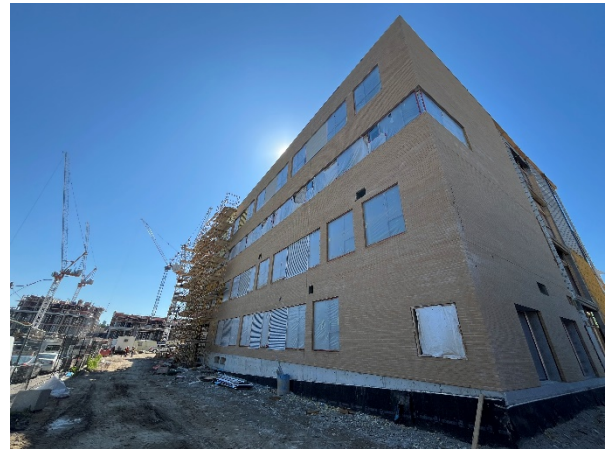
Picture taken from the North-West looking at the four-storey school. The exterior brick veneer was recently installed completed and punch windows have been installed.

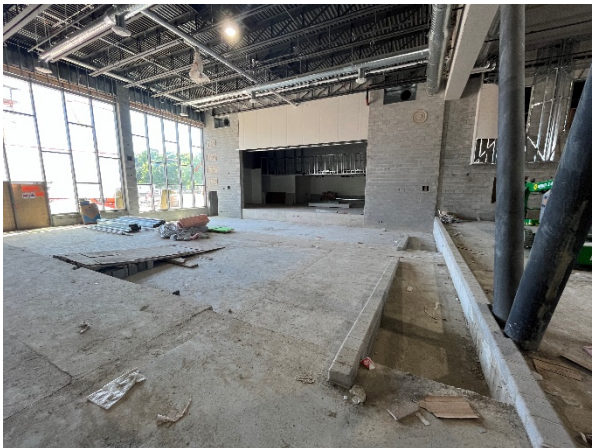
Picture of the student commons area looking at the stage. Steel stud framing and drywall finishes has started. Exposed ceiling ductwork has been recently completed.

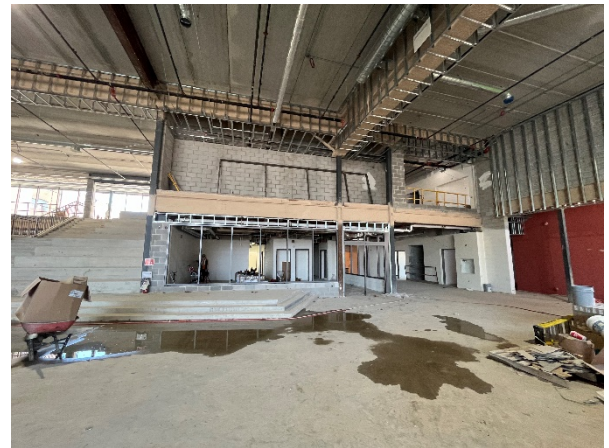
Picture of the student commons area looking at the main office and staircase. Steel stud framing and drywall finishes has commenced.

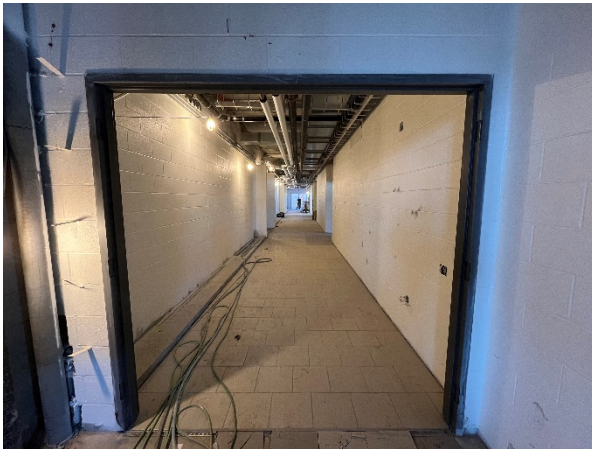
Picture looking down the ALPHA II Alternative school hallway. Porcelain tile has been recently installed.

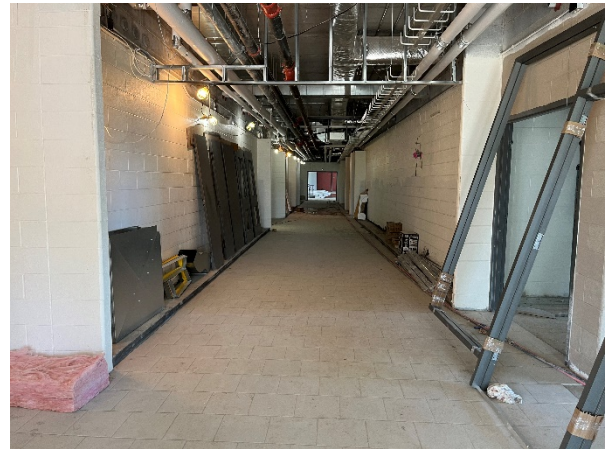
Picture looking down the North/South hallway of the first floor. Porcelain tile has been recently installed and ceiling is commencing.

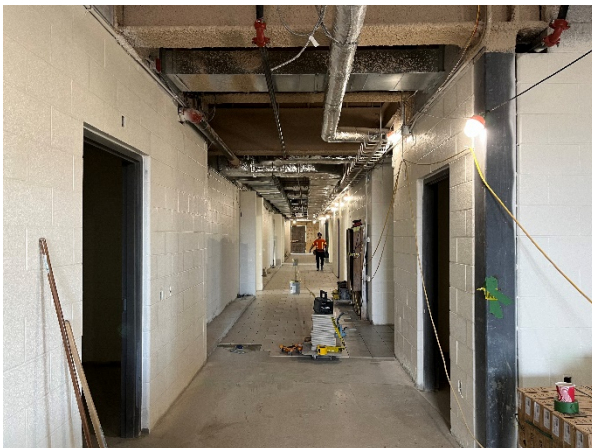
Picture of the East/West hallway on the second floor. Walls have been primed and porcelain tile was recently installed.

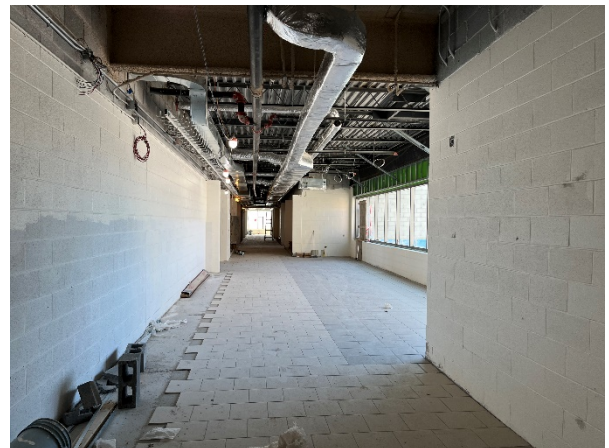
Picture of the North/South hallway on the second floor. Walls have been primed and porcelain tile was recently installed.

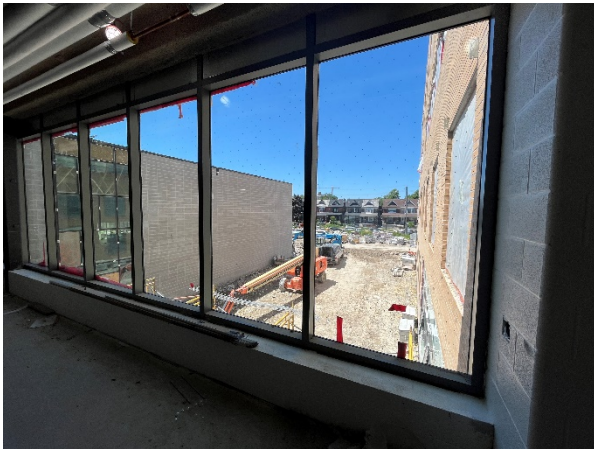
Picture looking out into the outdoor courtyard. Curtainwall glazing was recently installed, exterior block and brick veneer was recently completed.

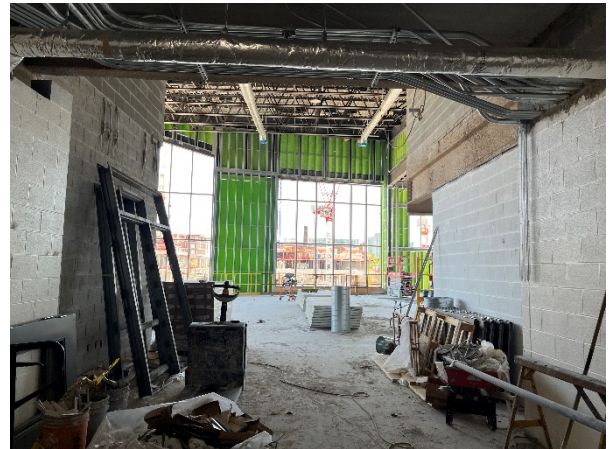
Picture from the library entrance on the third floor. The exterior wall was recently built, and the curtainwall mullions were recently installed.

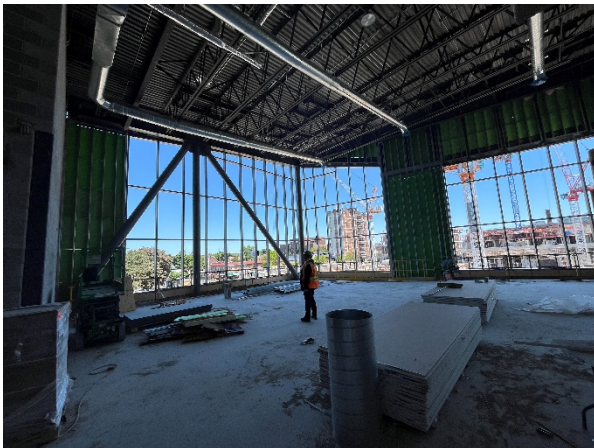
Picture of the library looking to the North. The exterior wall was recently built, and the curtainwall mullions were recently installed.

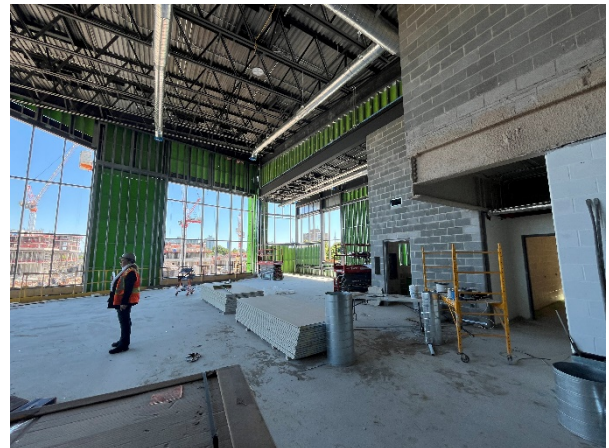
Picture of the library looking to the South. The exterior wall was recently built, and the curtainwall mullions were recently installed.
